Take a load off your mind

Local service for Queensland industry

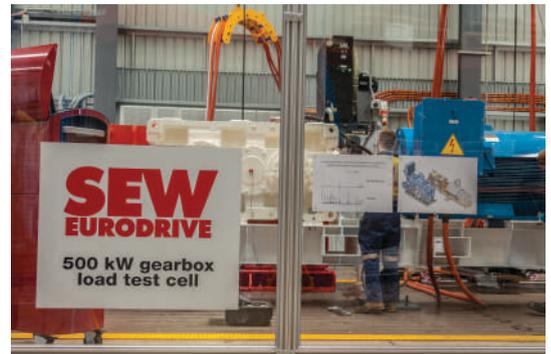
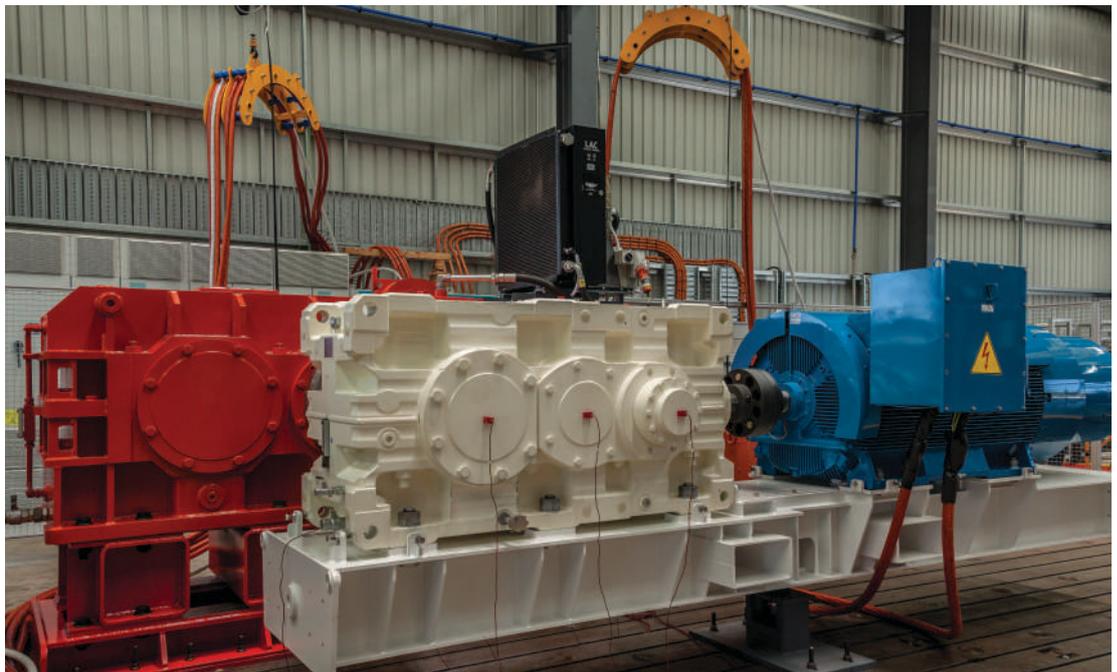
Figure 1
The GEARtest facility
at SEW-EURODRIVE in
Mackay.

The load testing facility – the first of its kind in Queensland – has been built in collaboration with the Melbourne-based CNC Design, a specialist in large machine automation systems. CNC Design has extensive experience in load testers for both industrial and wind turbine gear units in Australia and USA. The facility is capable of load testing up to a power level of 500 kW and 600 kNm of torque. Simpler spin testing and partial load

testing up to 1.5 MW are also available. In addition to load testing gear units, in most cases SEW-EURODRIVE will be able to load test the entire gearbox, motor and swing-base assembly. This can be done as a shaft-mounted assembly that closely replicates site mounting. Motors up to 6.6 kV can also be load tested. GEARTest, as it is known, is a back-to-back setup to test the gear units up to 100% full load with minimum energy consumption. The drive motor is connected to the gearbox undergoing the test, and the output shaft of the gearbox is in turn connected to a special-purpose

SEW-EURODRIVE speed-matching test gearbox unit, itself driving another motor acting as a generator. The test rig is controlled by an advanced motion control system, so the load cases and test sequences are flexible and can be adjusted to the specific test plan for each gear system.

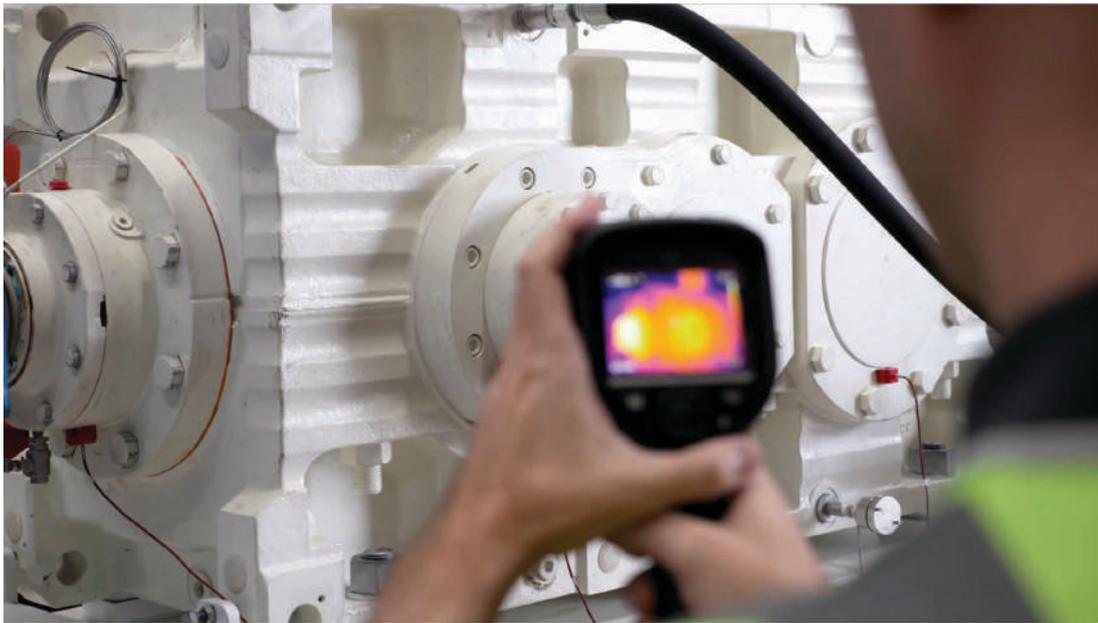
Figure 2
Thermal image of a gearbox under test

The system uses a Fast Fourier Transform (FFT) Spectrum analysis of vibration to identify any potential bearing, gear, or shaft defects. The load test loads the bearings and gearing in such a way as to avoid gear mesh backlash that can cause errors in the vibration analysis. The analysis of the vibration readings and the subsequent reporting is always conducted by an independent third party company. The test protocol will take the gearbox through various tests (with loaded gear teeth) that will detect potential misalignment, including misalignment caused by load, speed or temperature, while temperature logging as well as thermal imaging are used to evaluate gearbox thermal performance. Noise levels can also be checked for compliance with noise requirements.
